## A GEOTECHNICAL ASPECTS OF CASE STUDY DOCUMENTATION IN ANALYSING THE INFLUENCE OF SHRINK SWELL CHARACTERISTICS OF EXPANSIVE SOIL ON LOW RISE STRUCTURES.

**Author: Dr. CHANDRA MOHAN** (Lecturer, Civil Engineering Department, Motilal Nehru Govt. Polytechnic college, Puducherry (email:ssrajarani10@gmail.com))

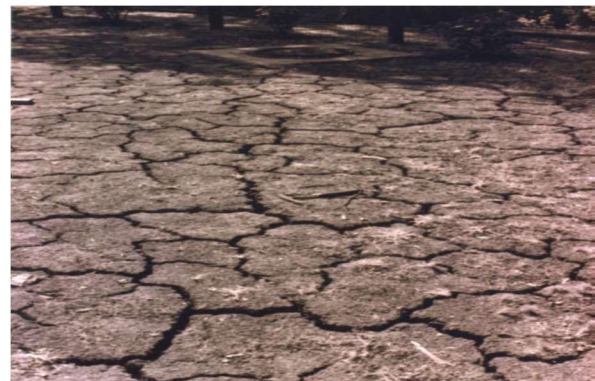
**Figure1: Polygonal pattern of surface cracks in the dry season.**  
These cracks are approximately one inch wide at the top.

Expansive soils in many parts of the world pose a significant hazard to foundations for light buildings. Swelling clays derived from residual soils can exert uplift pressures of as much as 5,500 PSF, which can do considerable damage to lightly-loaded wood-frame structures. Insurance companies pay out millions of dollars yearly to repair homes distressed by expansive soils. Expansive soils have in-depth swelling characteristics due to the presence of swelling clay minerals. Swelling clays can control the behavior of virtually any type of soil if the percentage of clay is more than about 5 percent by weight. Soils with smectite clay minerals, such as montmorillonite, exhibit the most profound swelling properties. Potentially expansive soils can typically be recognized in the lab by their plastic properties. Inorganic clays of high plasticity, generally those with liquid limits exceeding 50 percent and plasticity index over 30, usually have high inherent swelling capacity. In the field, expansive clay soils can be easily recognized in the dry season by the deep cracks, in roughly polygonal patterns, in the ground surface (Figure. 1).

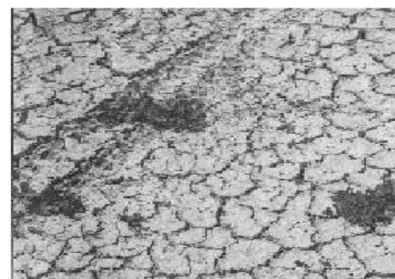
Figure 2. Identification of expansive soil from (Masoumeh Mokhtari, Masoud Dehghani.2012 vol.17, Bund.R).

Expansive soil with cracks

Expansive soil with "popcorn" texture

Soil that cracks or fractures when it dries is often a sign that it is expansive; however a lack of cracks does not necessarily indicate that the soil is not expansive (Masoumeh Mokhtari, Masoud Dehghani. 2012 vol.17, Bund.R). Soils containing expansive clays become very sticky when wet and usually are characterized by surface cracks or a "popcorn" texture when dry. Expansive soils take on a popcorn like appearance when they dry, they look like lumps of popcorn shaped dirt on the soil surface, and it is shown in the Figure 2. Expansive soils are often clay like, becoming very sticky when wet and hard and brittle when dry. The best way to determine if the soil at a location is expansive is to have an expansion test performed by a soil expert.

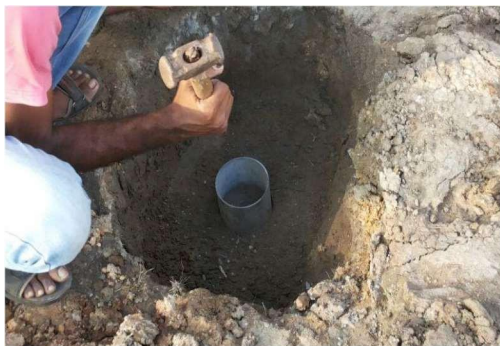
**Figure 6. Typical open pits manually excavated using pick-axes and shovels**

The exploration composed of opening trial pits up to about 1 m below ground level at carefully earmarked locations. The chosen depth took into account the shallow depth of most of the foundations and the anticipated depth of active zone in the study area. The pits were excavated manually using pick-axes and shovels. Some of the photographs taken during the excavation are shown in Figure 6. Undisturbed samples from the pits were recovered from carefully marked depths using hand tools such as knives, trowels and shovels disturbed samples were also retrieved from the pit, sealed, packaged, logged and transported to the laboratory.

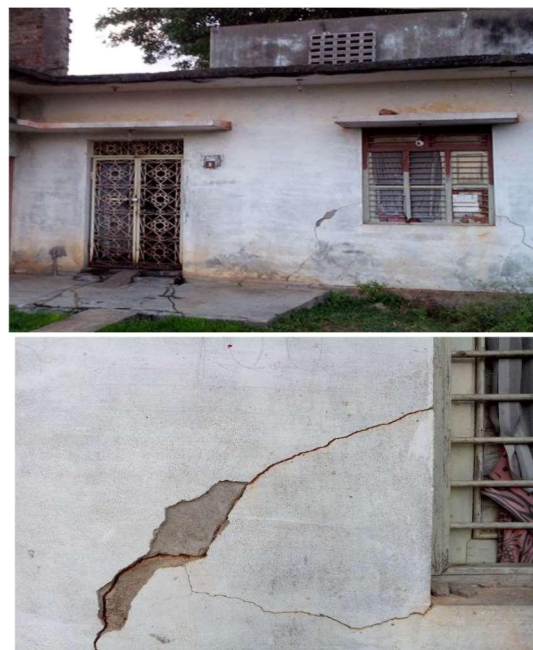
**Figure7.Building inspection in Krishna nagar**

- The building found in Krishna nagar (L1) presents a typical case history on the expansive soils., constructed in the year 2000. This is the typical study of what happens when a lightweight structure rests on expansive soil without considering the swell pressure. Figure.7 shows a building in a state of

damage due to heaving occurred in Krishna nagar. Cracks found in building originated in the corners and radiated either up or down at about 45°. Most of the buildings had developed diagonal cracks with a stair-step pattern in external walls.

1. Control the shrink-swell behaviour through the following alternatives;
  - Replace existing expansive soil with non-expansive soil.
  - Maintain a constant moisture content.
  - Improve the expansive soils by stabilization
2. Tolerate the damage.
3. Underpinning the existing foundations.
4. Repair the cracked walls.
5. Enforcement of construction industry regulations.

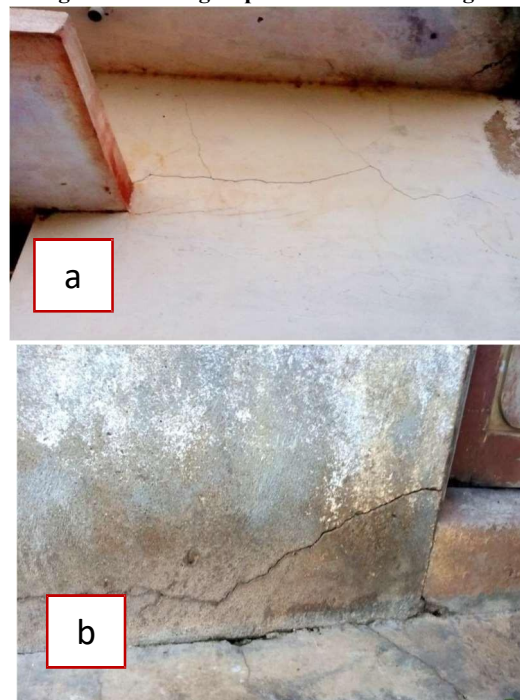
- In Venkata nagar (L2) the sample covered a mixture of buildings ranging from single-storey buildings to 2-storey residential buildings. Most of the single-storey structures have masonry walling or cement bricks, laid directly on the foundation wall supported by a spread plain concrete footing cast continuously around the perimeter of the building. Figure.8 (a) and (b) shows the building damage in Venkata nagar having horizontal crack developed between the ground slab and the external substructure wall. In many cases, the initial cracks have been propagating and increasing in width as with time goes.

**Figure.8 (a) horizontal crack formation near window-(L2)**  
**Figure.8(b) horizontal crack formation developed between the ground slab and the external substructure wall**

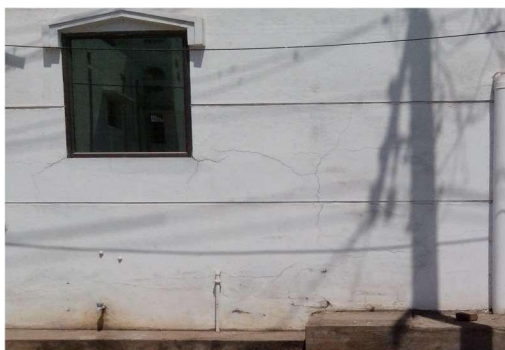
- In Bahore (L3) buildings ranging from single-storey buildings to 2-storey buildings. Most of the buildings are constructed by isolated foundations. Figure. 9 shows the typical damage of external wall in 2 storey building with multiple hairline cracks of varying length.

Figure.9 crack developed in external wall (L3)

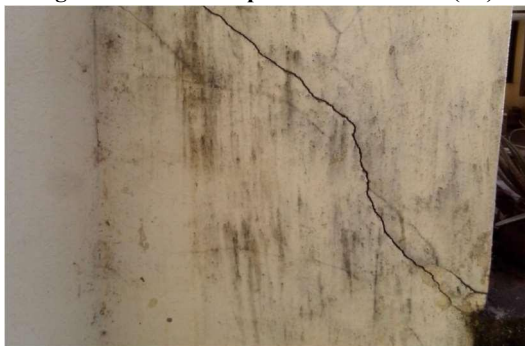
- In Koodapakkam (L4) the building was constructed according to the standard engineering practice but the expansive soils were not taken into account because of the lack of adequate soil investigation. The cracks were originating from floor towards the roof and it is classified as moderate to severe degree of visible damages according to classification in Table 1. The figure 10.shows the typical crack pattern observed in the building constructed in year 2000. It clearly shows that building undergone significant settlement.

Figure.10 crack developed in external wall (L4)
